## **Appendix K.**

**Photographs of Study Sites on the Illinois Waterway (Photographs of the Mississippi River Sites are on file with the Rock Island District, U.S. Army Corps of Engineers)**

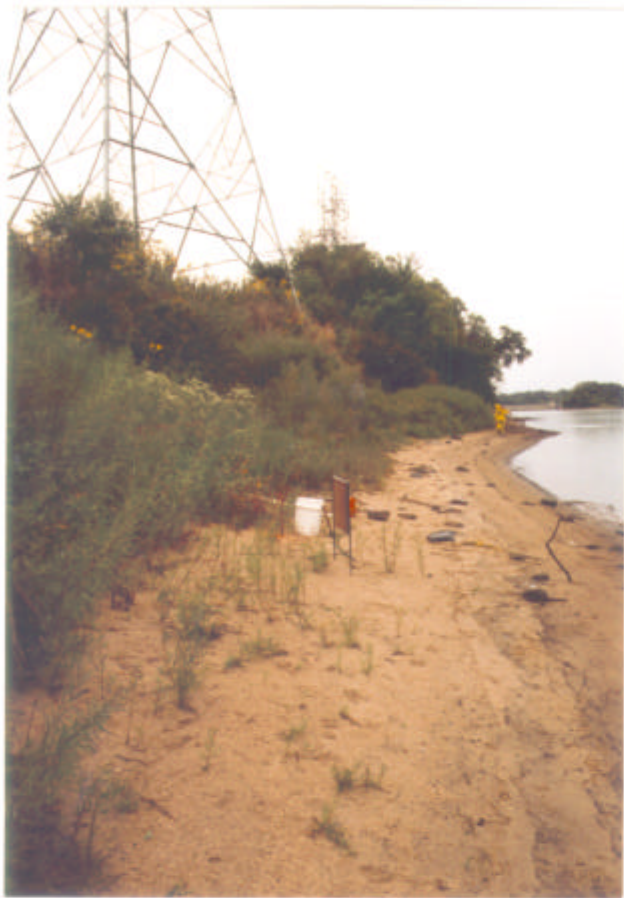
Site UP1, RDB of RM 270.3, Looking upstream

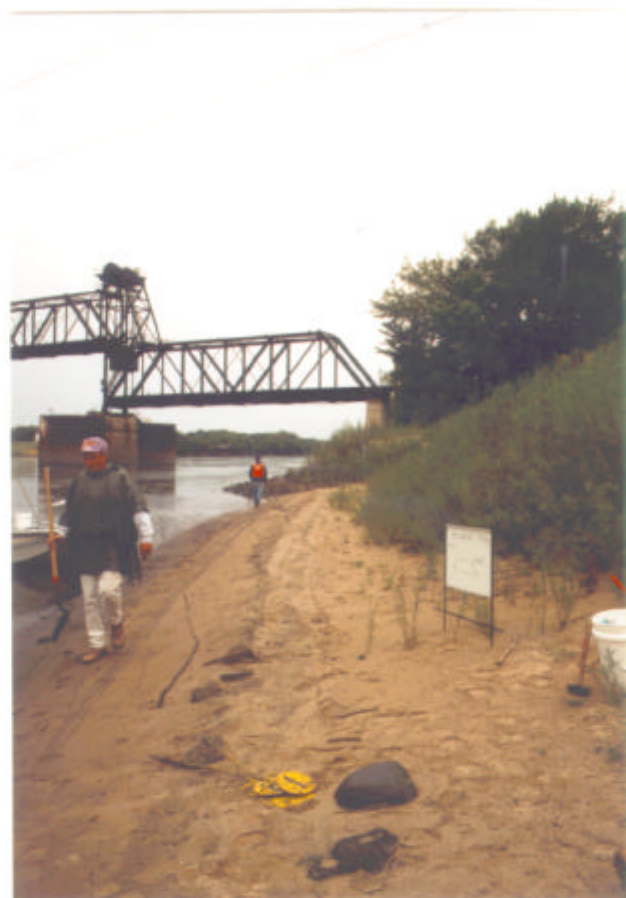
Site UP1, RDB of RM 270.3, Looking downstream

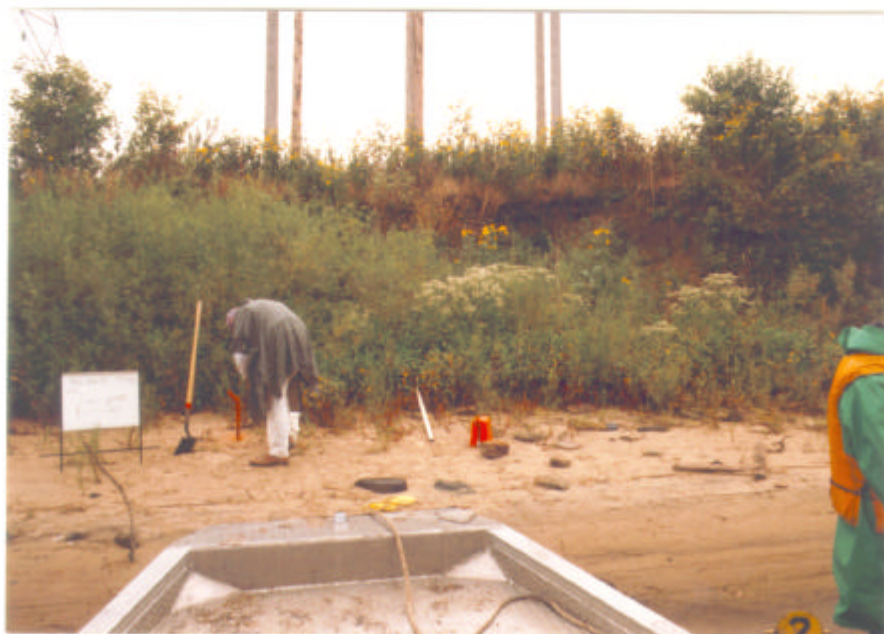
Site UP1, RDB of RM 270.3, Site overview

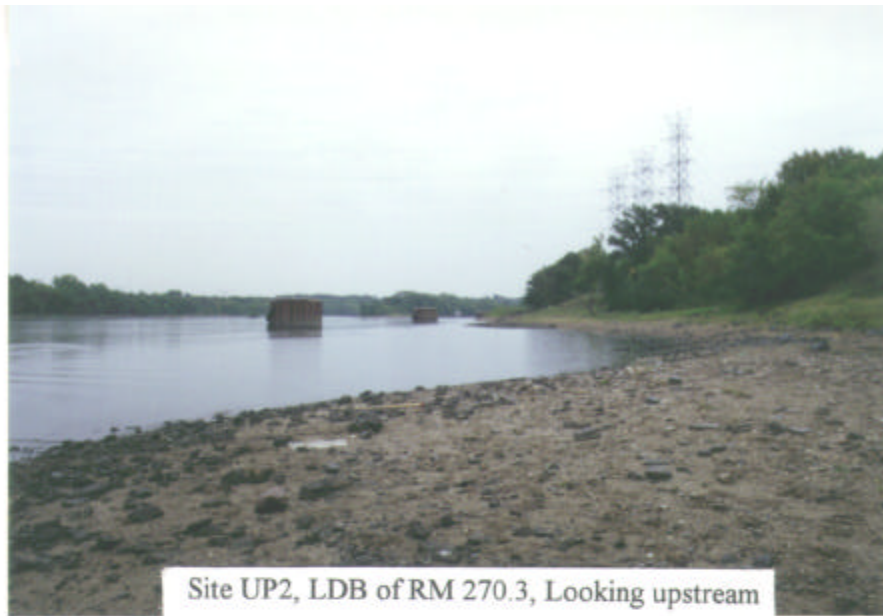
Site UP2, LDB of RM 270.3, Looking upstream

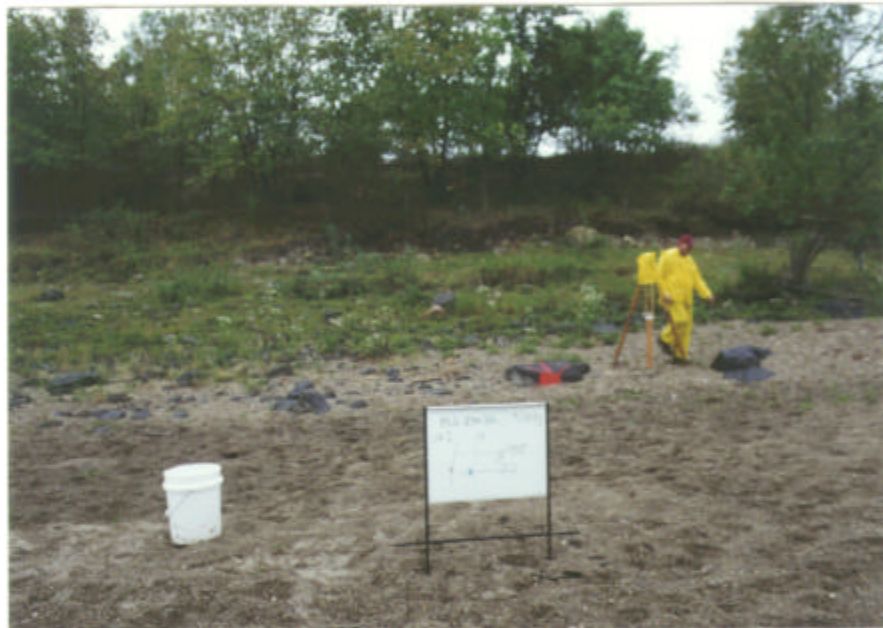
Site UP2, LDB of RM 270.3, Site view

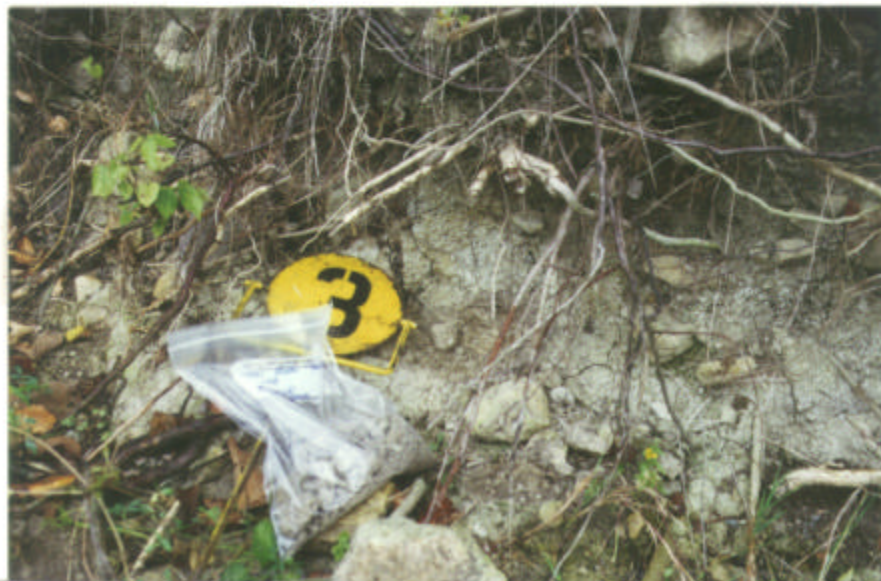
Site UP2, LDB of RM 270.3, Scarp face with sample mark #3 and a sample bag

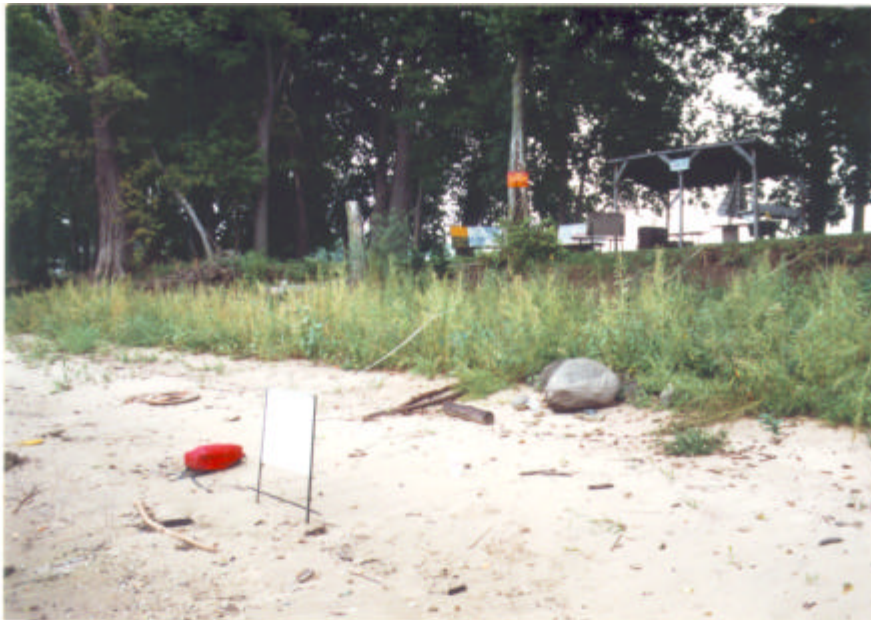
Site UP3, LDB of RM 264.3, Site view with a booth on top of bank

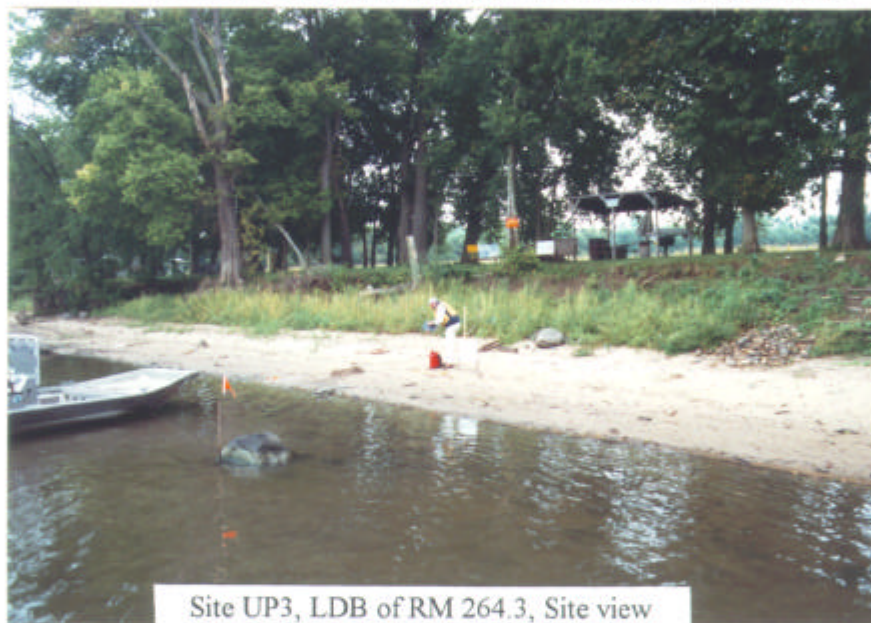
Site UP3, LDB of RM 264.3, Site view

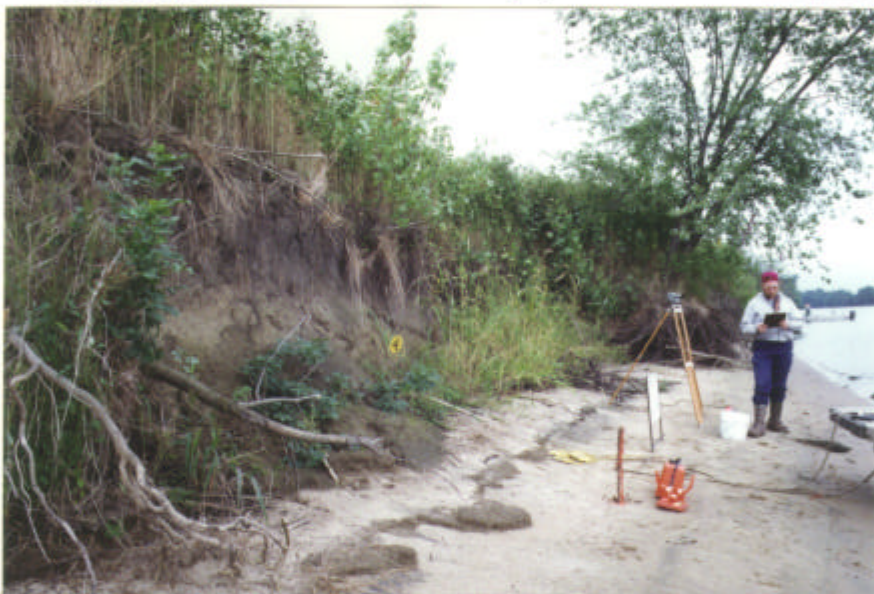
Site UP4, LDB of RM 262.1, Mid-section with Mike Cox taking notes

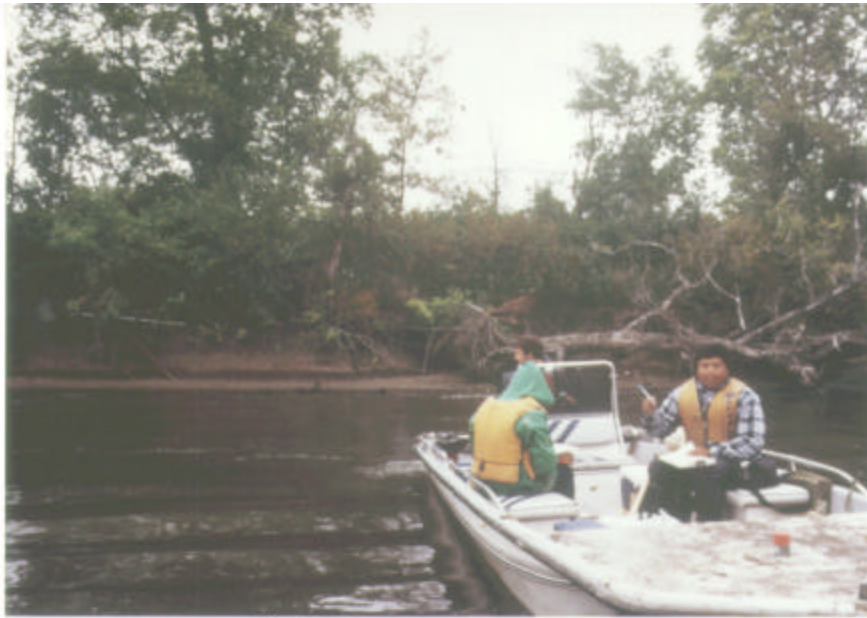
Site UP5, RDB of RM 262.1, Site view

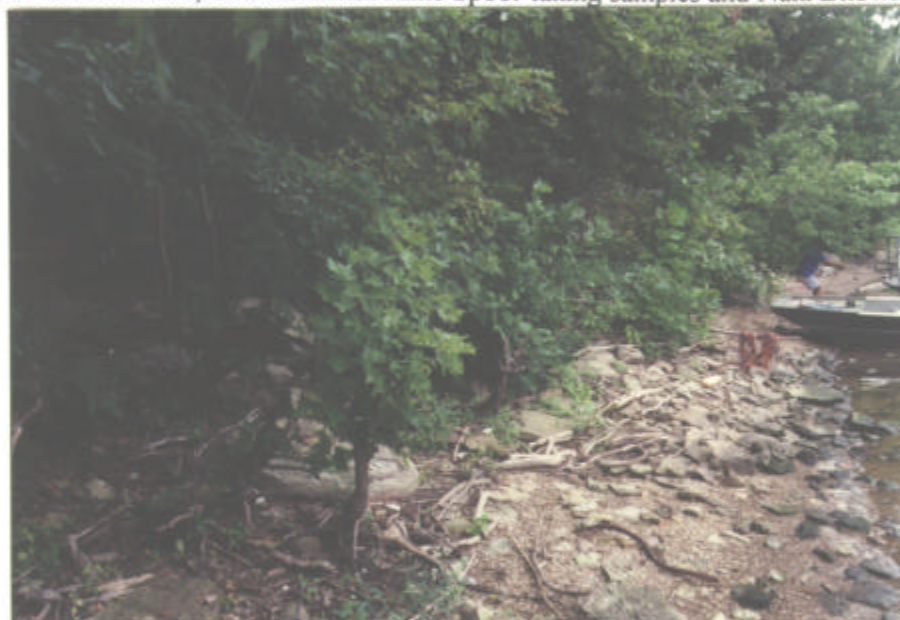
Site 1, LDB of RM 242.9, Looking downstream

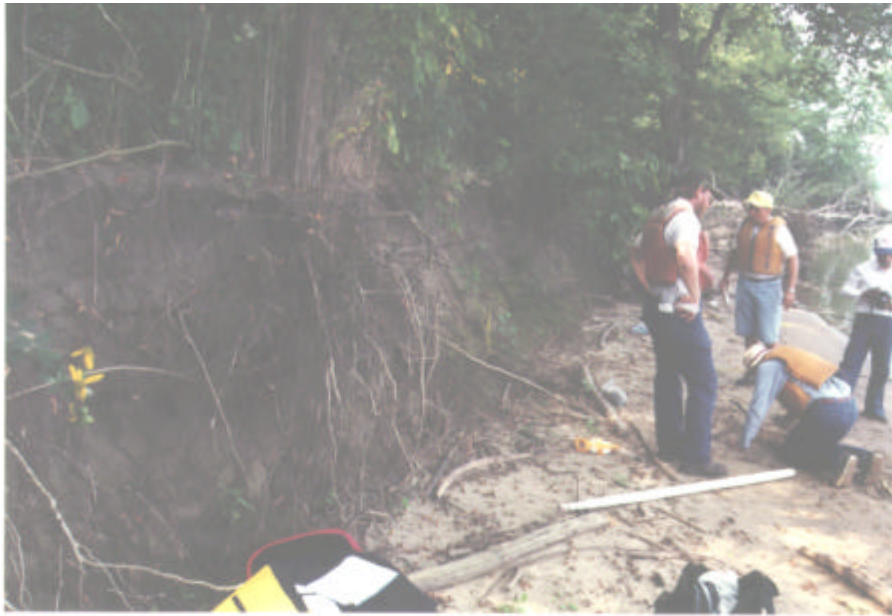
Site 2, LDB of RM 243.4, Site view with crews taking data

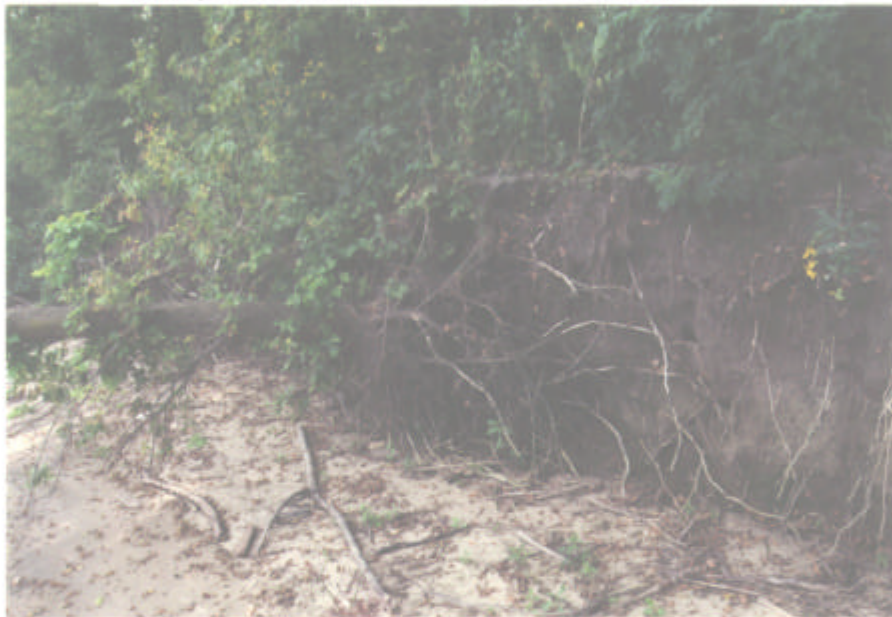
Site 2, LDB of RM 242.4, Looking upstream

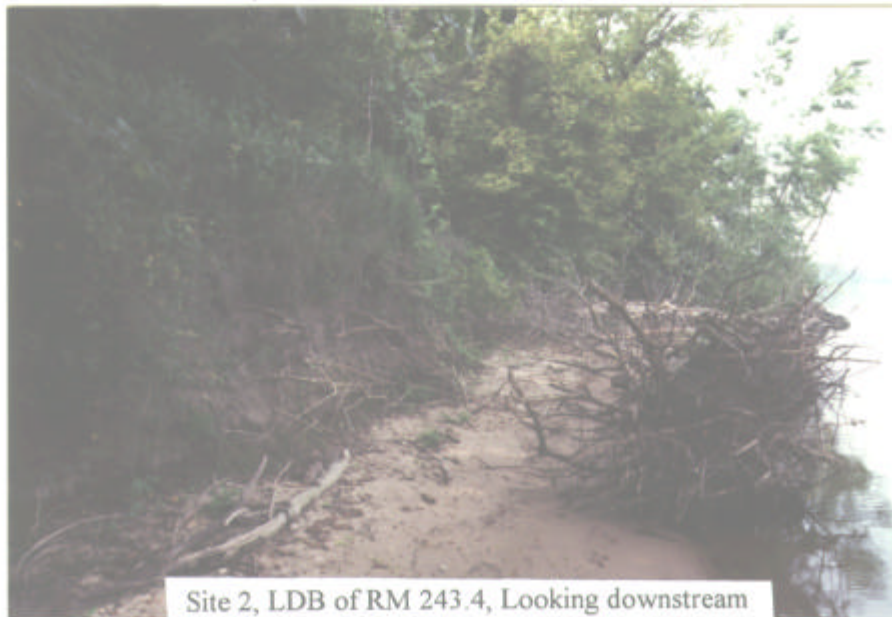
Site 2, LDB of RM 243.4, Looking downstream

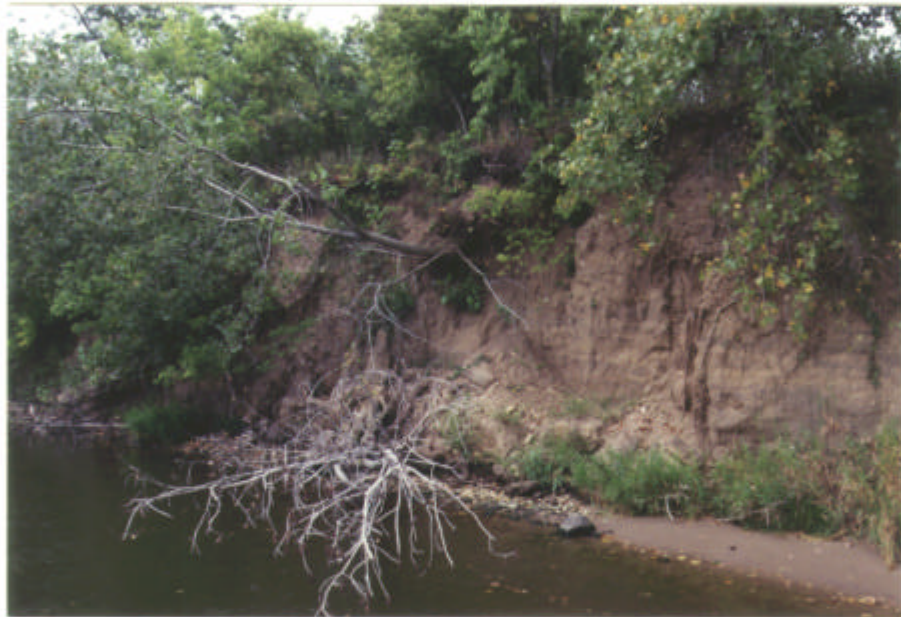
Site 3, RDB of RM 235.8, Looking downstream

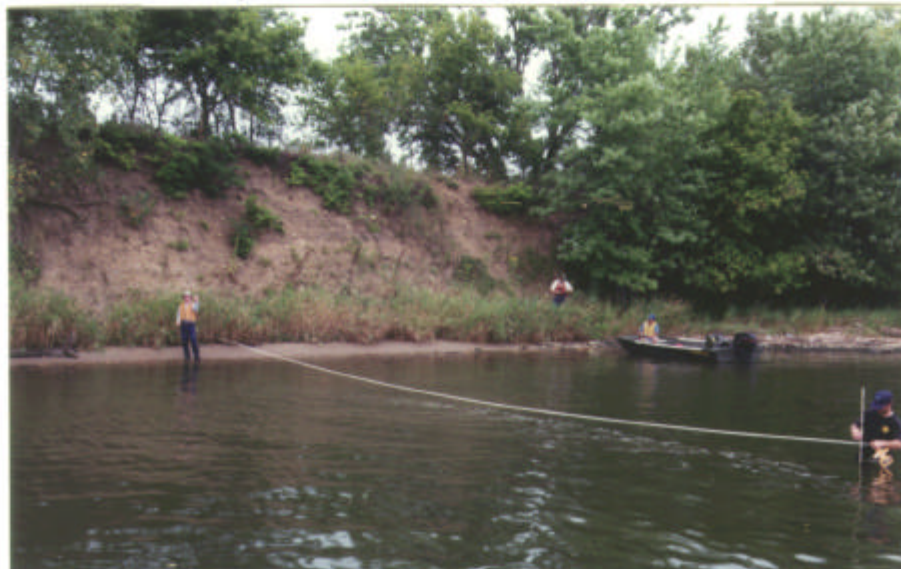
Site 3, RDB of RM 235.8, Site view with Mike Spoor and Jim Slowikowski measuring underwater bed profile

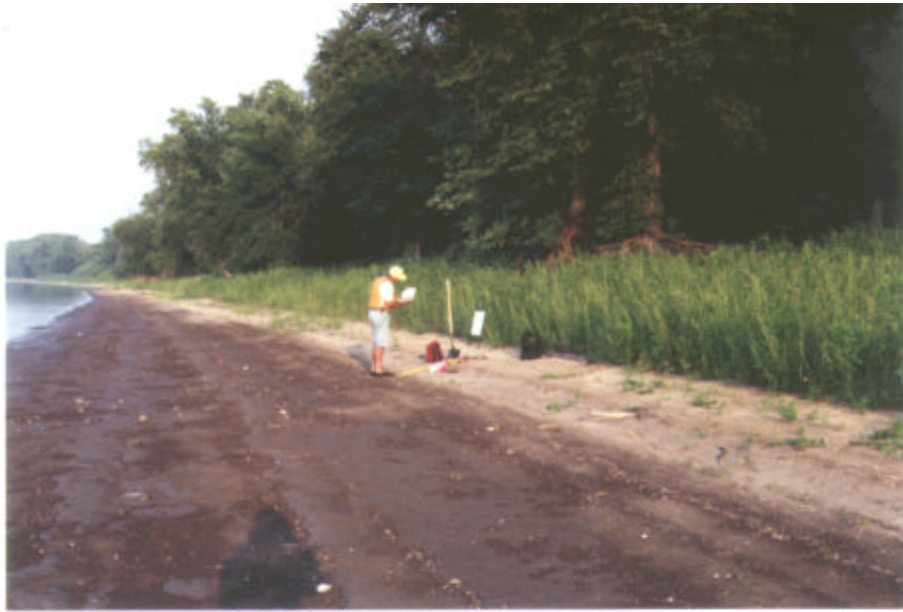
Site 4, LDB of RM 228.1, Site view with Dan Johnson filling in data sheet

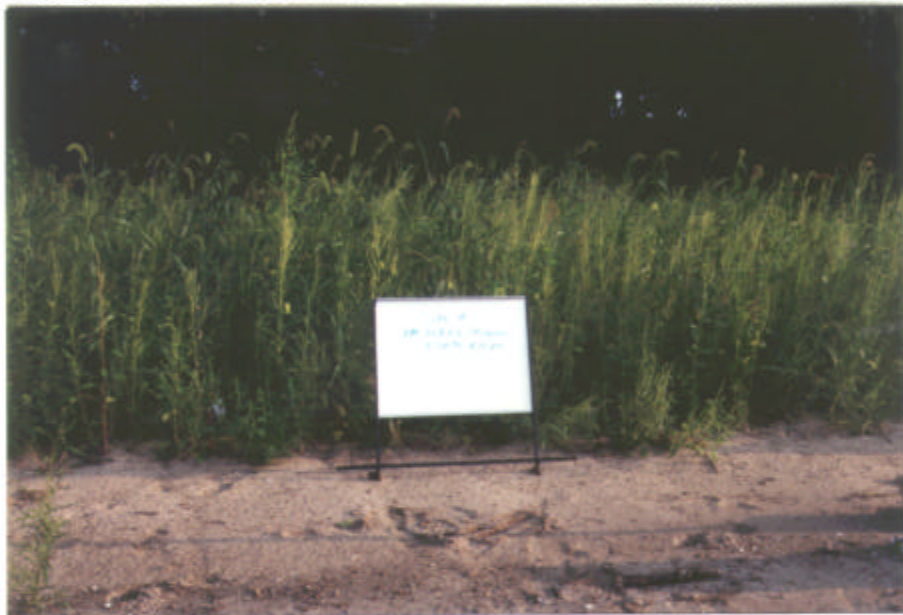
Site 4, LDB of RM 228.1, Site view with the sign for each midsection

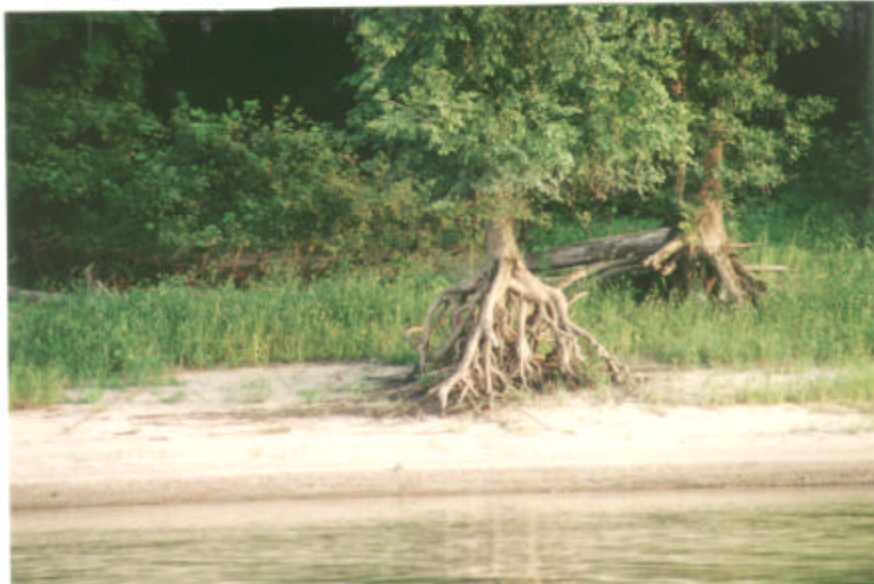
Site 4, LDB of RM 228.1, Downstream section view with exposed tree roots

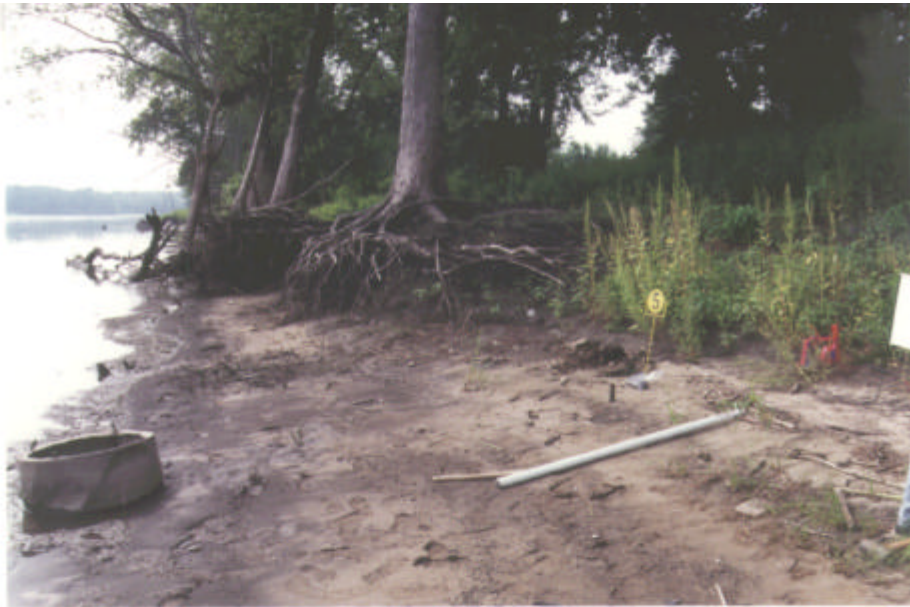
Site 6, RDB of RM 210.0, Site view with soil sampling location

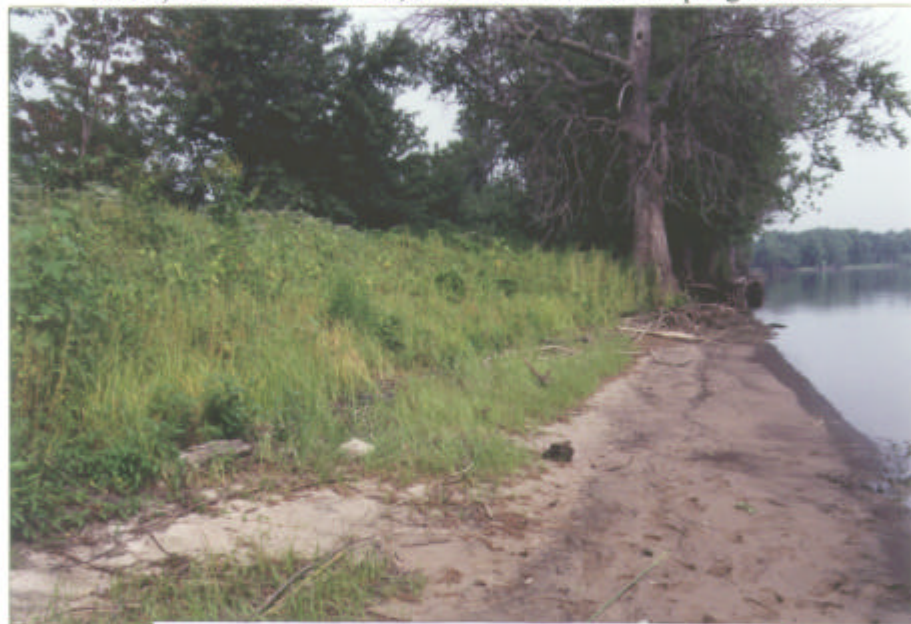
Site 6, RDB of RM 210.0, Looking upstream

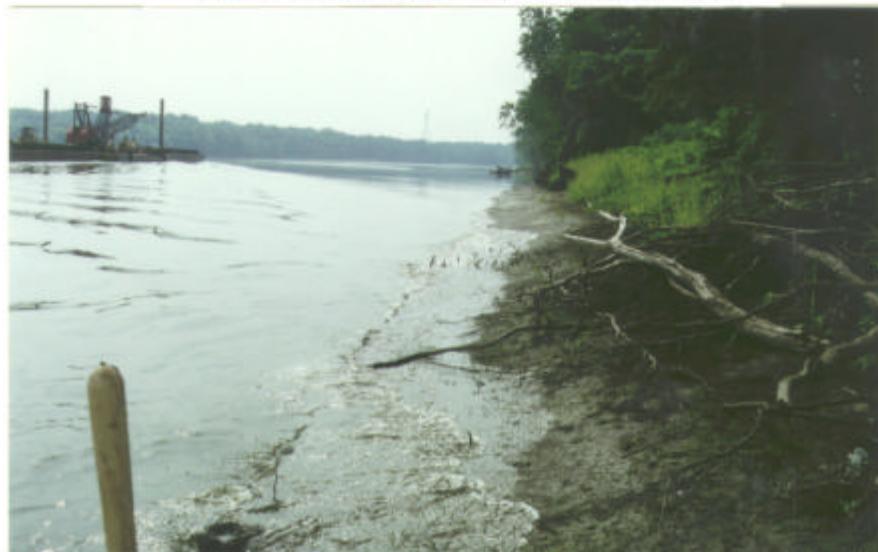
Site 6, RDB of RM 210.0, Looking downstream with a work barge passing the site and the SWS Monitor at the downstream limit

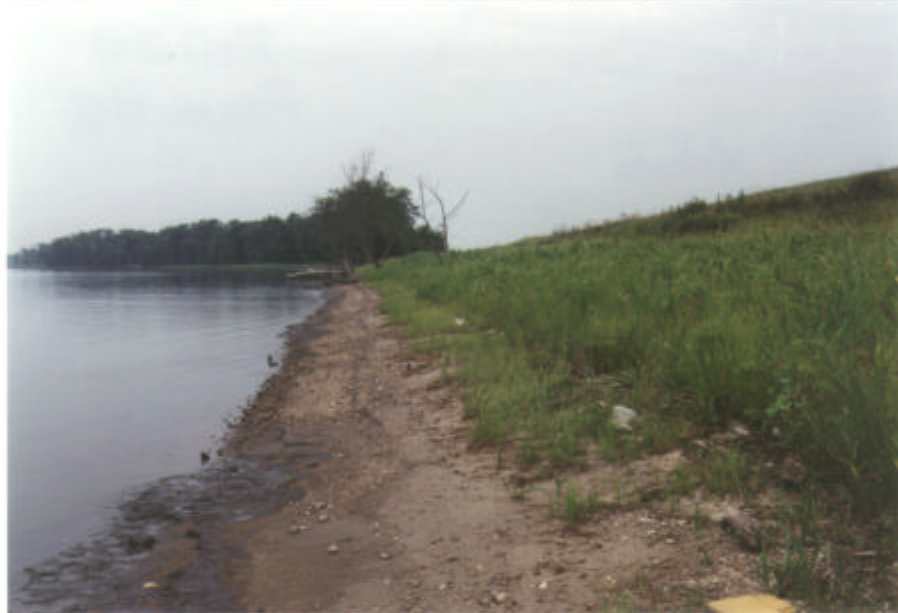
Site 7, LDB of RM 203.8, Looking upstream

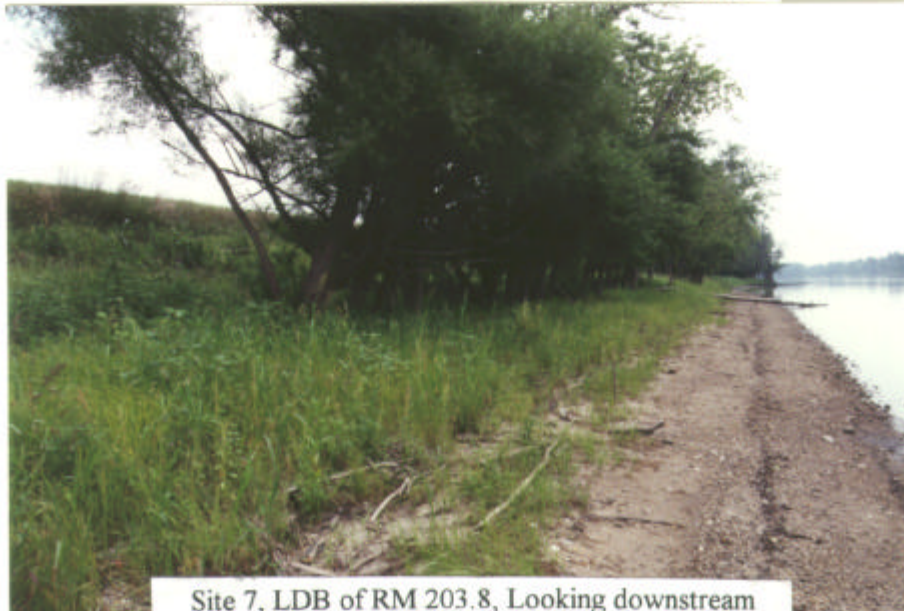
Site 7, LDB of RM 203.8, Looking downstream

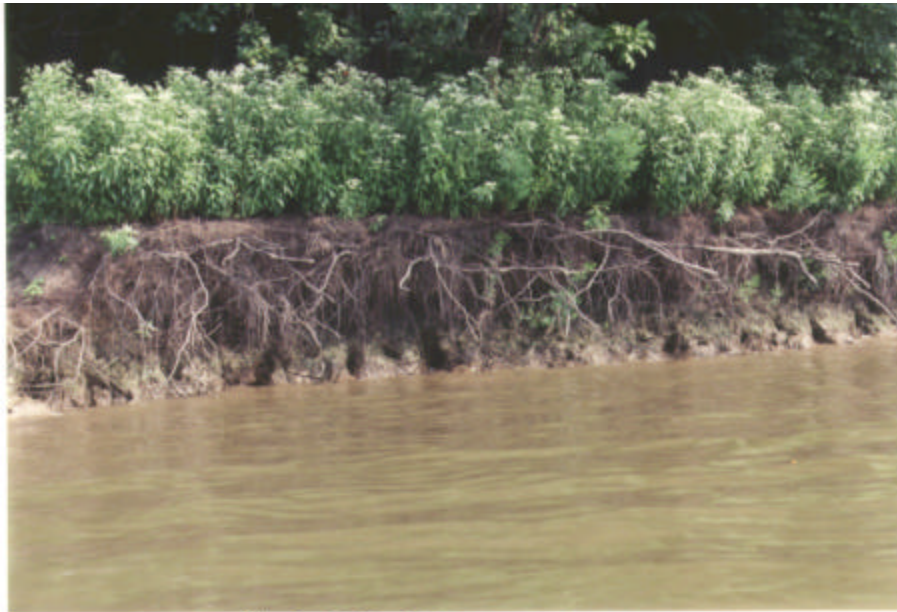
Site 8, LDB of RM 184.8, Site view

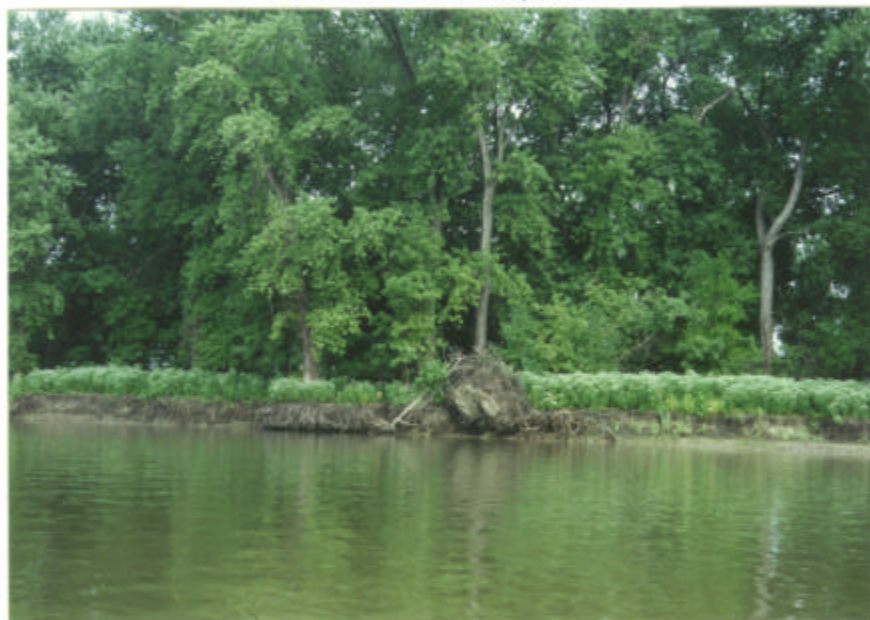
Site 8, LDB of RM 184.8, Site view

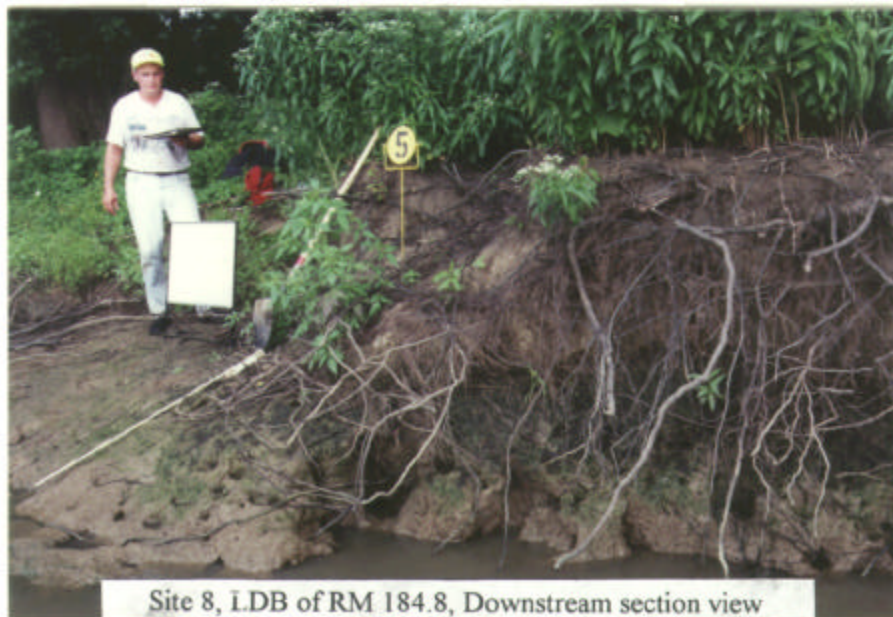
Site 8, LDB of RM 184.8, Downstream section view

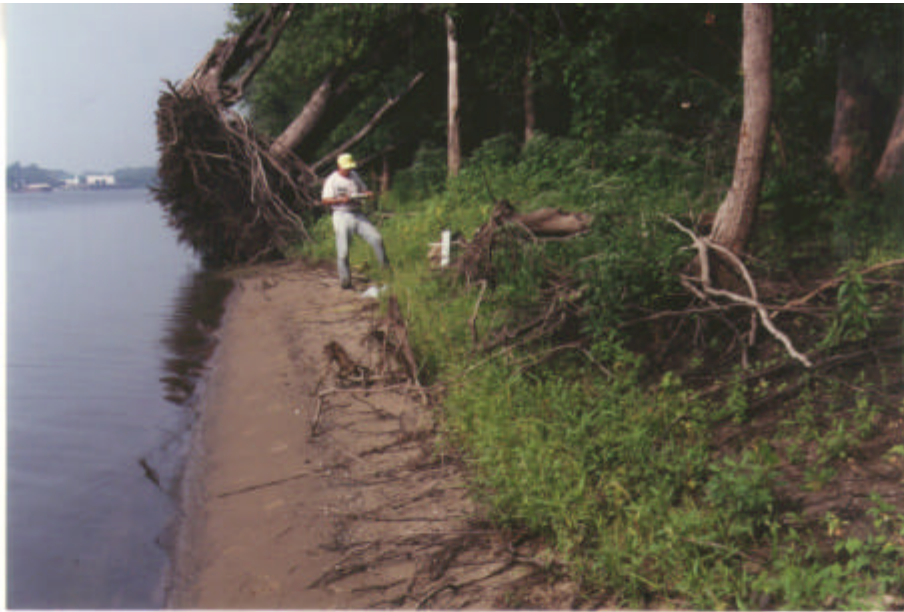
Site 9, LDB of RM 179.8, Looking upstream

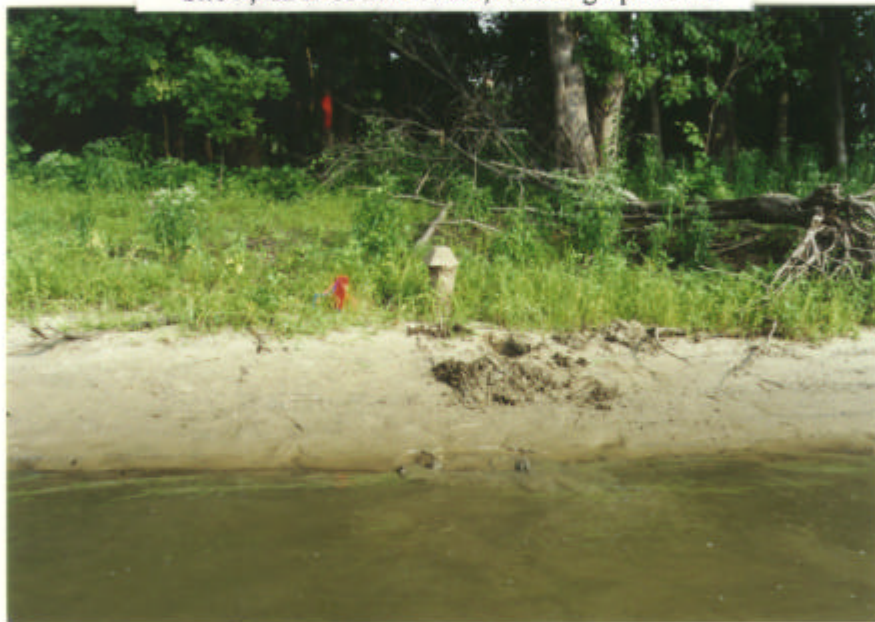
Site 9, LDB of RM 179.8, Mid-section view with an old monument.

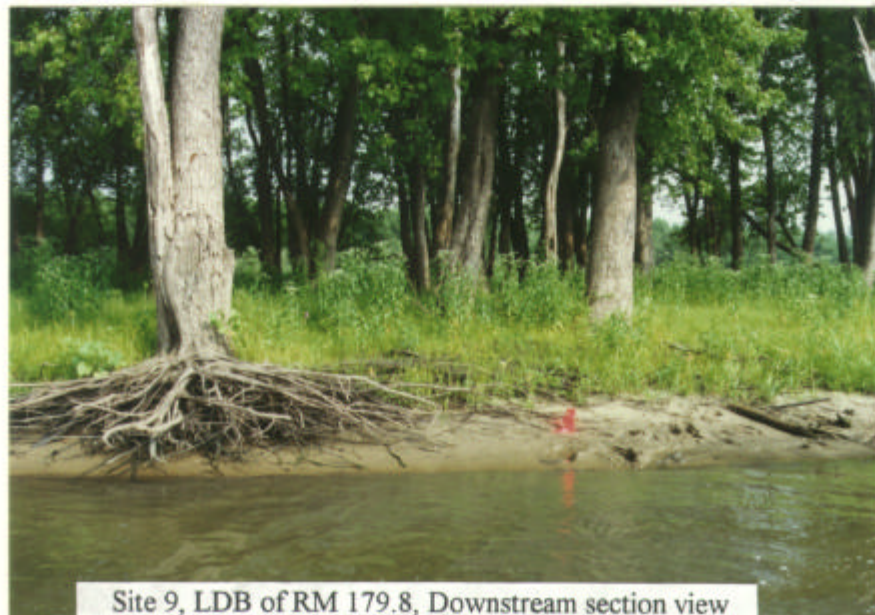
Site 9, LDB of RM 179.8, Downstream section view

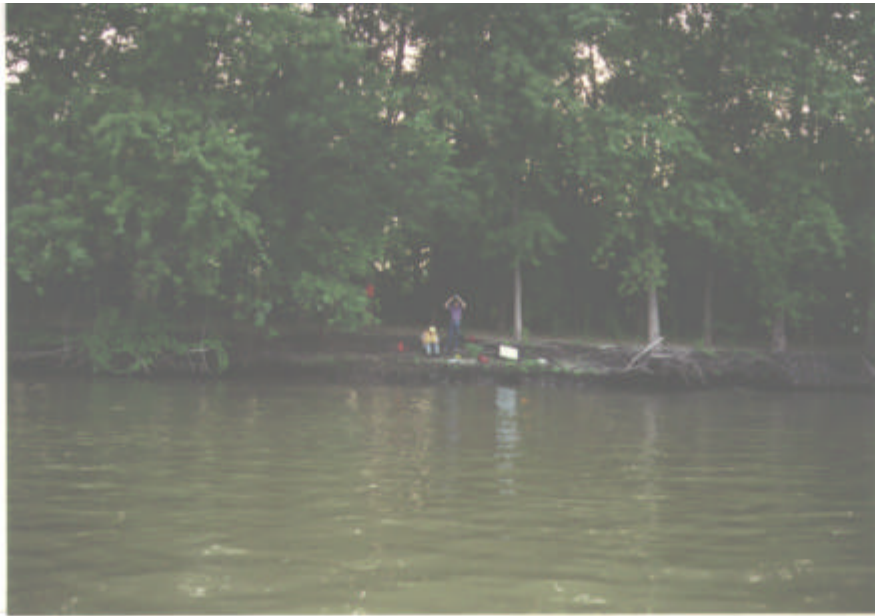
Site 10, RDB of RM 160.0, Mid-section view with Dan Johnson and Tatsuaki Nakato

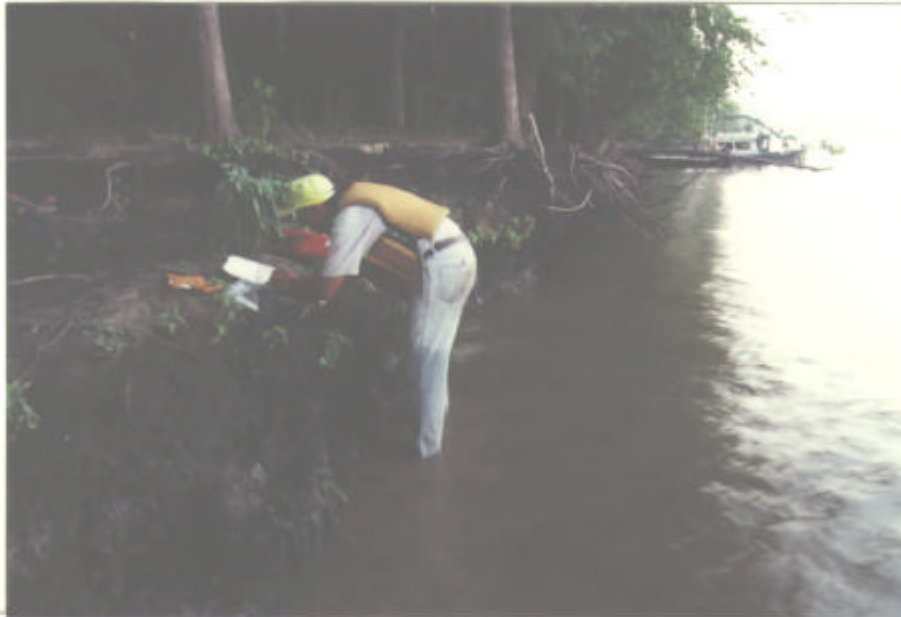
Site 10, RDB of RM 160.0, Close up of mid-section with Dan Johnson writing notes and the Monitor at the upstream section

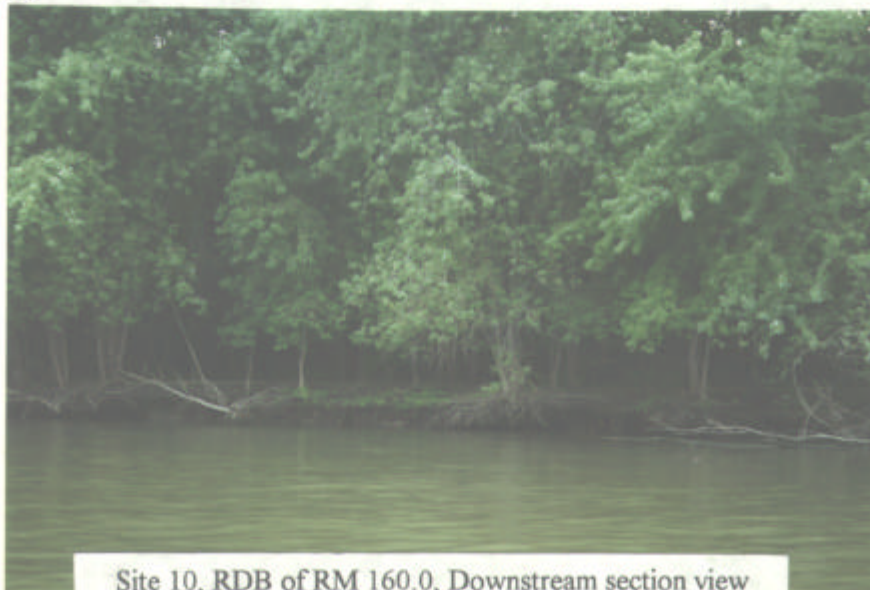
Site 10, RDB of RM 160.0, Downstream section view

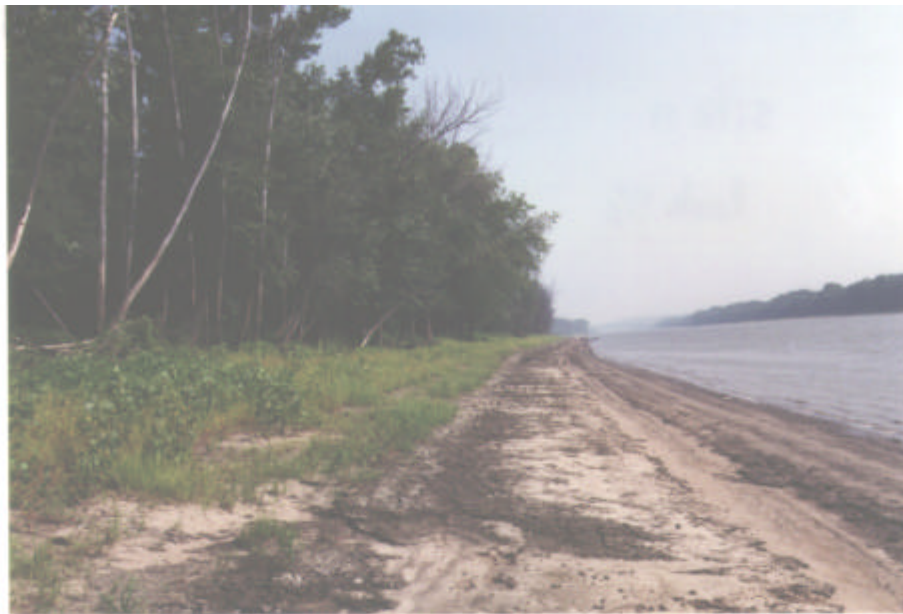
Site 11, RDB of RM 155.3, Looking upstream

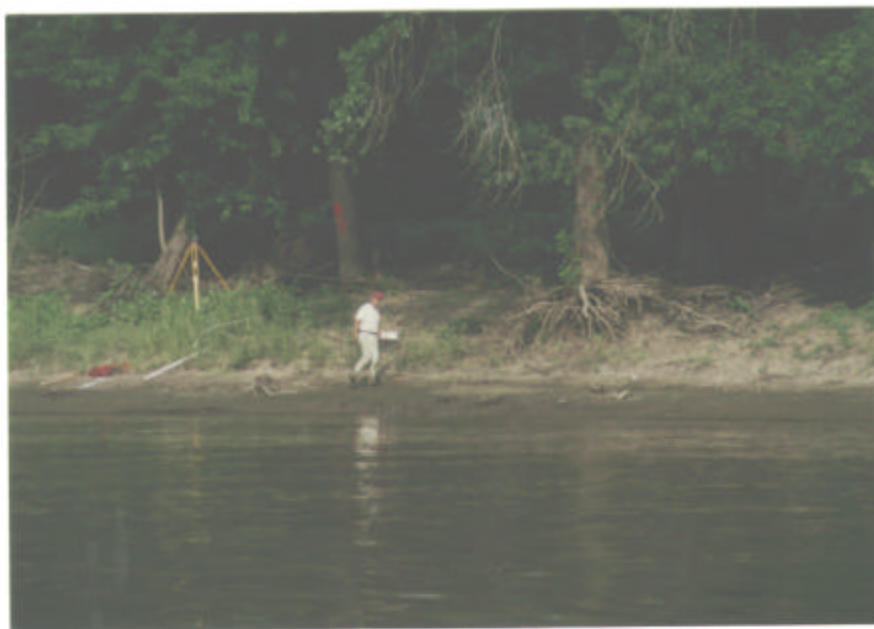
Site 16, LDB of RM 109.5, Scarp face at 100' upstream

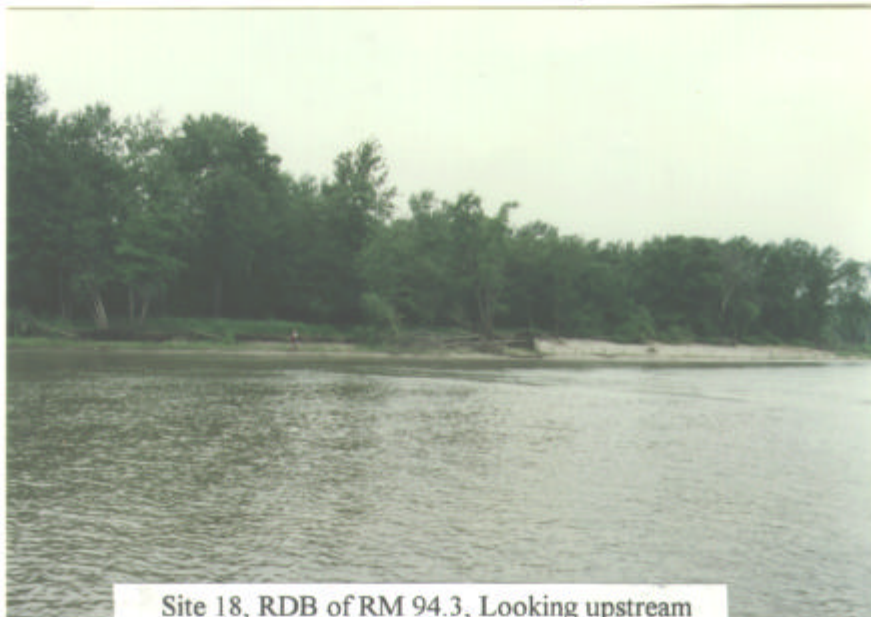
Site 18, RDB of RM 94.3, Mass collapsed on site

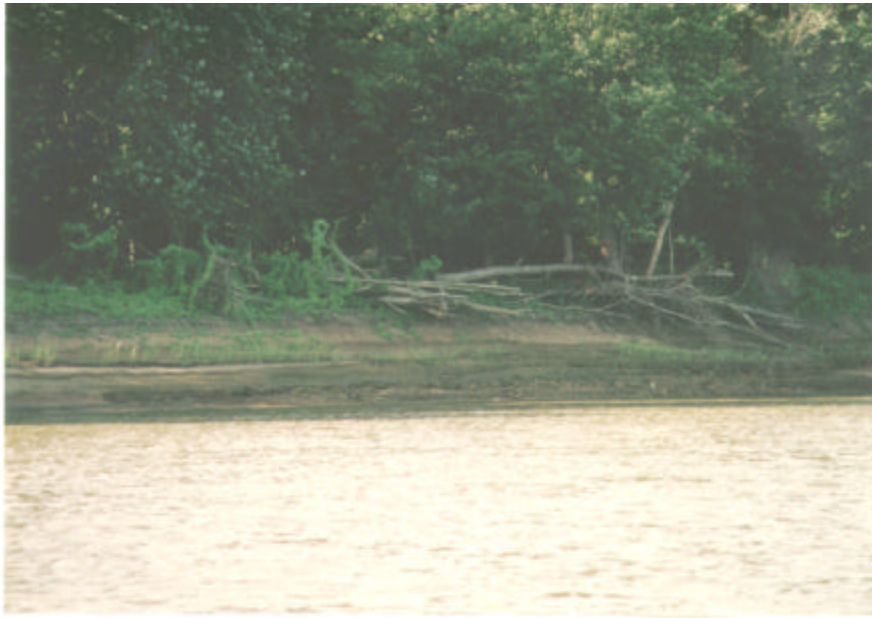
Site 20. RDB of RM 79.4, Sampling location of the bench where ground water showed up at the sampling hole
